Developing Science-Based Strategies to Manage Water Conveyance and Control Weeds and Sediment in Irrigation and Potable Water Supply Canals

R. MacArthur*, A. Rabidoux**, A. Shvidchenko*, L. Anderson***, B. Cruey*, J. Pan*

*Northwest Hydraulic Consultants (NHC), West Sacramento, CA

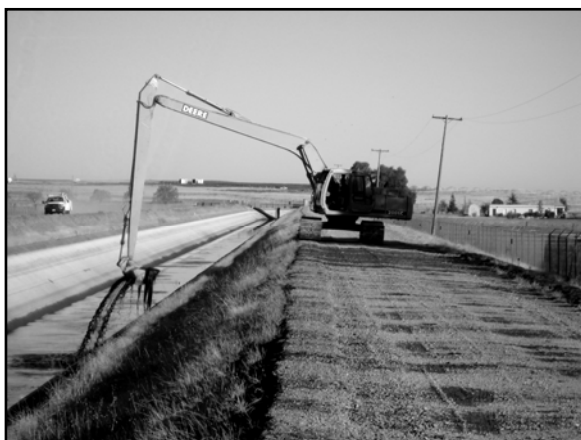
Figure 2. Removal of aquatic weeds and sediment from Sweeney Check at MP 6.15.
Photo of October 19, 2006.

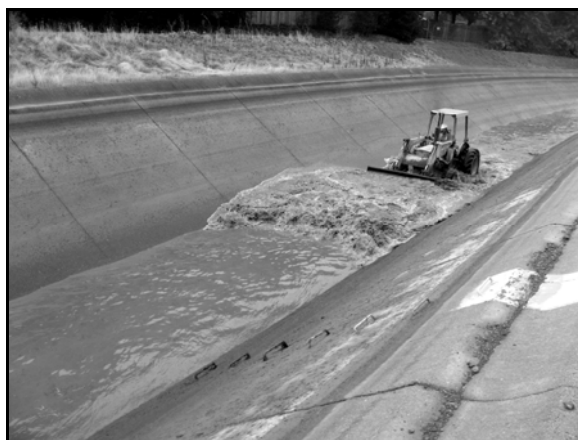
Figure 3. Pushing sediment and vegetative detritus down Union Check at MP 14.80.
Photo of November 3, 2006.

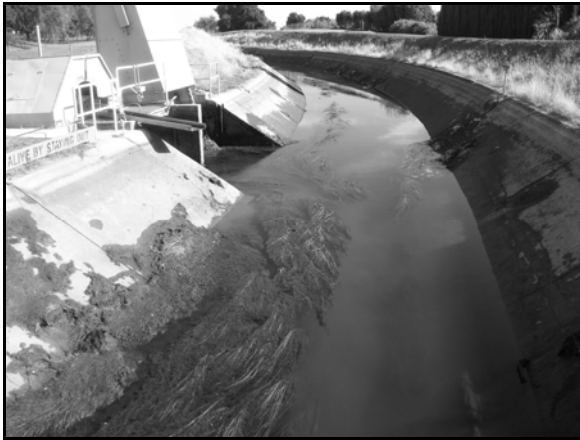
Figure 4. Thick growth of algae and macrophytes that plug the intake to the Waterman WTP located just upstream of Serpas Check. Photo of November 9, 2006.

There is an accumulation of the black anoxic floc-like organic material (Figures 4 and 5) deposited along the canal bottom each year as a direct result of the growth and decay of aquatic vegetation. There is also a close linkage between the sediment introduced into the canal, and the volume of aquatic biomass capable of being produced each year. Figure 6 illustrates the primary sources and relationships between sediment and vegetation in the canal. Deposited sediments provide nutrients and a location where colonization and growth of aquatic vegetation takes place, particularly aquatic macrophytes that rapidly colonize sediment deposits along the canal bottom, along the inside of canal bends, upstream of canal check structures, as well as in panel cracks and seams. Thick mature patches of aquatic macrophytes encourage further capture and settling of fine sediments from the water column, and provide a location where inorganic sediments combine with vegetation and other organic detrital materials. These thick mats of sediment and organic bottom materials become anaerobic during the summer and fall and generate hydrogen sulfide and other odor-causing and water quality treatment problems, especially during annual canal cleanout operations when these deposited materials are disturbed. Thick growths of aquatic vegetation can clog irrigation turnouts, plug drip emitters, reduce water treatment plant intake efficiency, and lead to increased operations and maintenance costs. This situation occurs

frequently at the Waterman WTP's Intake that is located just upstream from the Serpas Check structure (Figure 4).

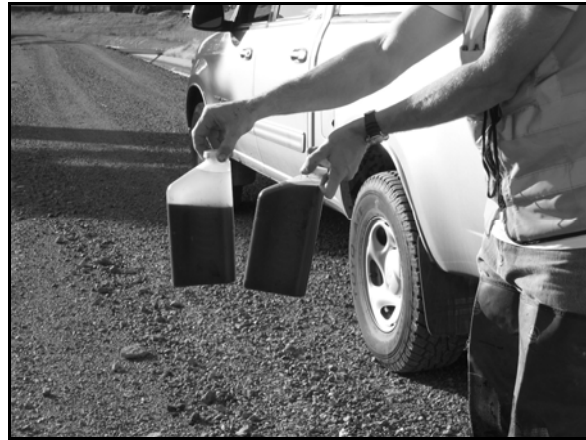
Figure 5. Water samples from Putah South Canal collected during 2007 cleanout. The sample on the right was just collected; the sample on the left had settled for about 30 minutes. Both samples contain high concentrations of organic materials (decomposed vegetative materials) with a little sediment.

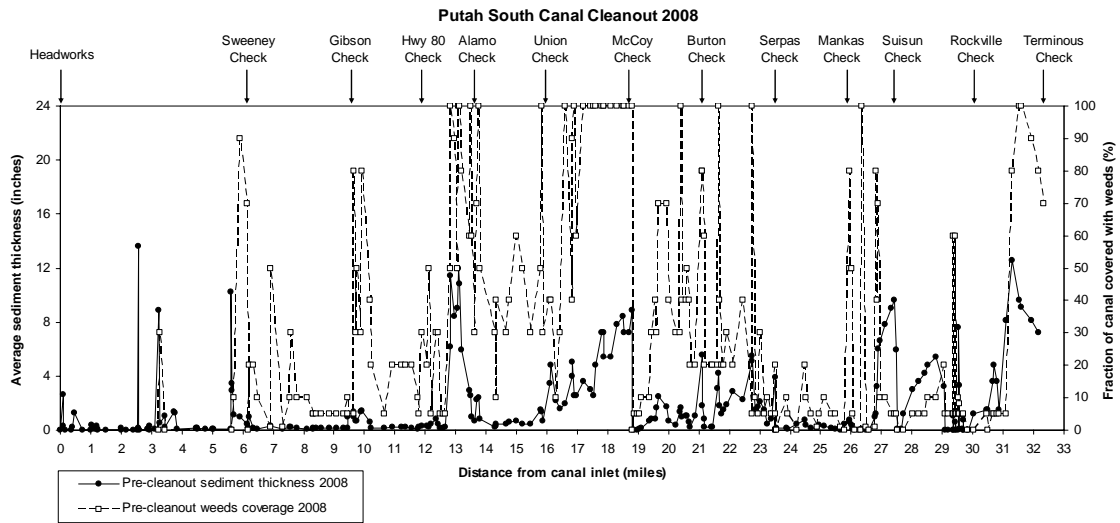
Figure 7. Longitudinal variations of average thickness of sediment deposits and weed growth prior to fall 2008 cleanout.

During the fall periods of 2006, 2007 and 2008, just prior to canal cleanout, NHC measured the approximate thickness of sediment deposits along the canal and estimated the percent coverage of aquatic vegetation in all checks along the canal (Figure 7). NHC observed a range of volumes of sediment deposits on the order of 1,000 to 12,000 cubic yards per year depending on rainfall and runoff conditions that occur during a given rainy season. During these three years the greatest sediment deposition, and thickest weed populations, were observed to occur upstream from checks, along the inside of canal bends and in areas where there is usually some sediment accumulated on the canal bottom. During the 2008 canal cleanout monitoring, NHC estimated the total weed volume within each check before and after canal cleanout. These results are shown in Figure 8. Total volume of weeds in the canal prior to and after the cleanout were approximately 2,000 and 100 cubic yards, respectively.
